Strengthening Capacities in the Western Balkans Countries to Address Environmental Problems through Remediation of High Priority Hot Spots

Environmental Hot Spot Serbia Remediation of the Grand Backa Canal

Monitoring of surface water and sediments quality in the Grand Backa Canal

MNE, 6-7/5/09

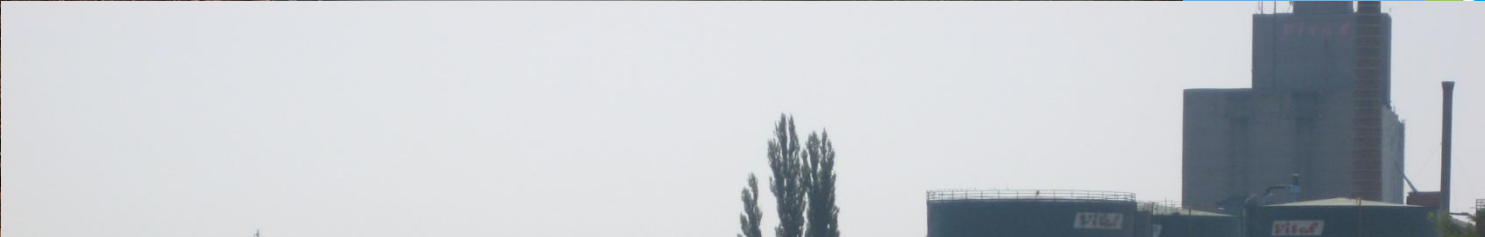
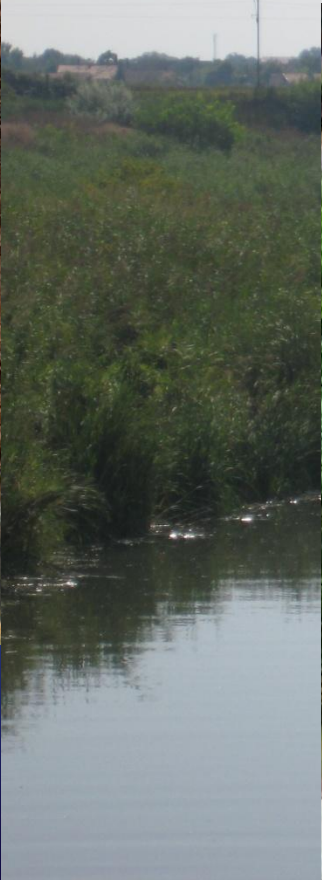
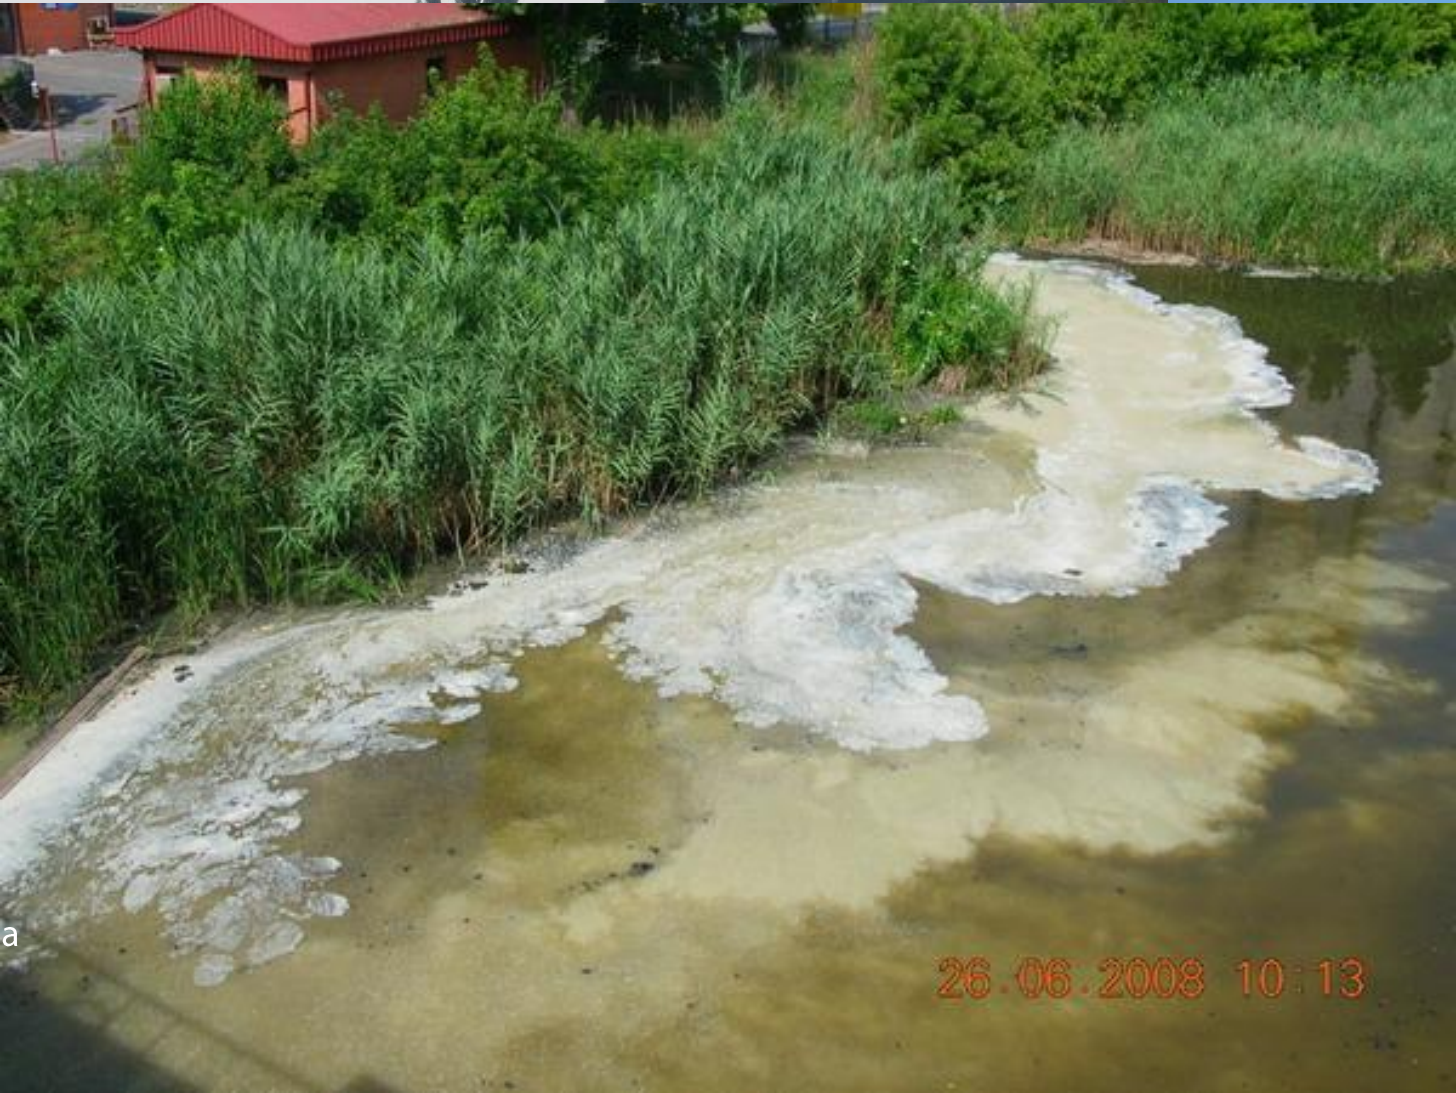
Photos 1-4: UNDP Serbia

- Cadastre of polluters registers 22 polluters
- Most of the polluters discharge untreated waste water into lateral canal I-64 and subsequently into the GBC
- The biggest polluters are: meat industry “Carnex” with its “Farmacoop” pig farm in Vrbas, sugar refineries in Vrbas and Crvenka, communal waste water from Vrbas and Kula, cooking oil factory “Vital” in Vrbas, metal and leather processing factories in Kula and others.

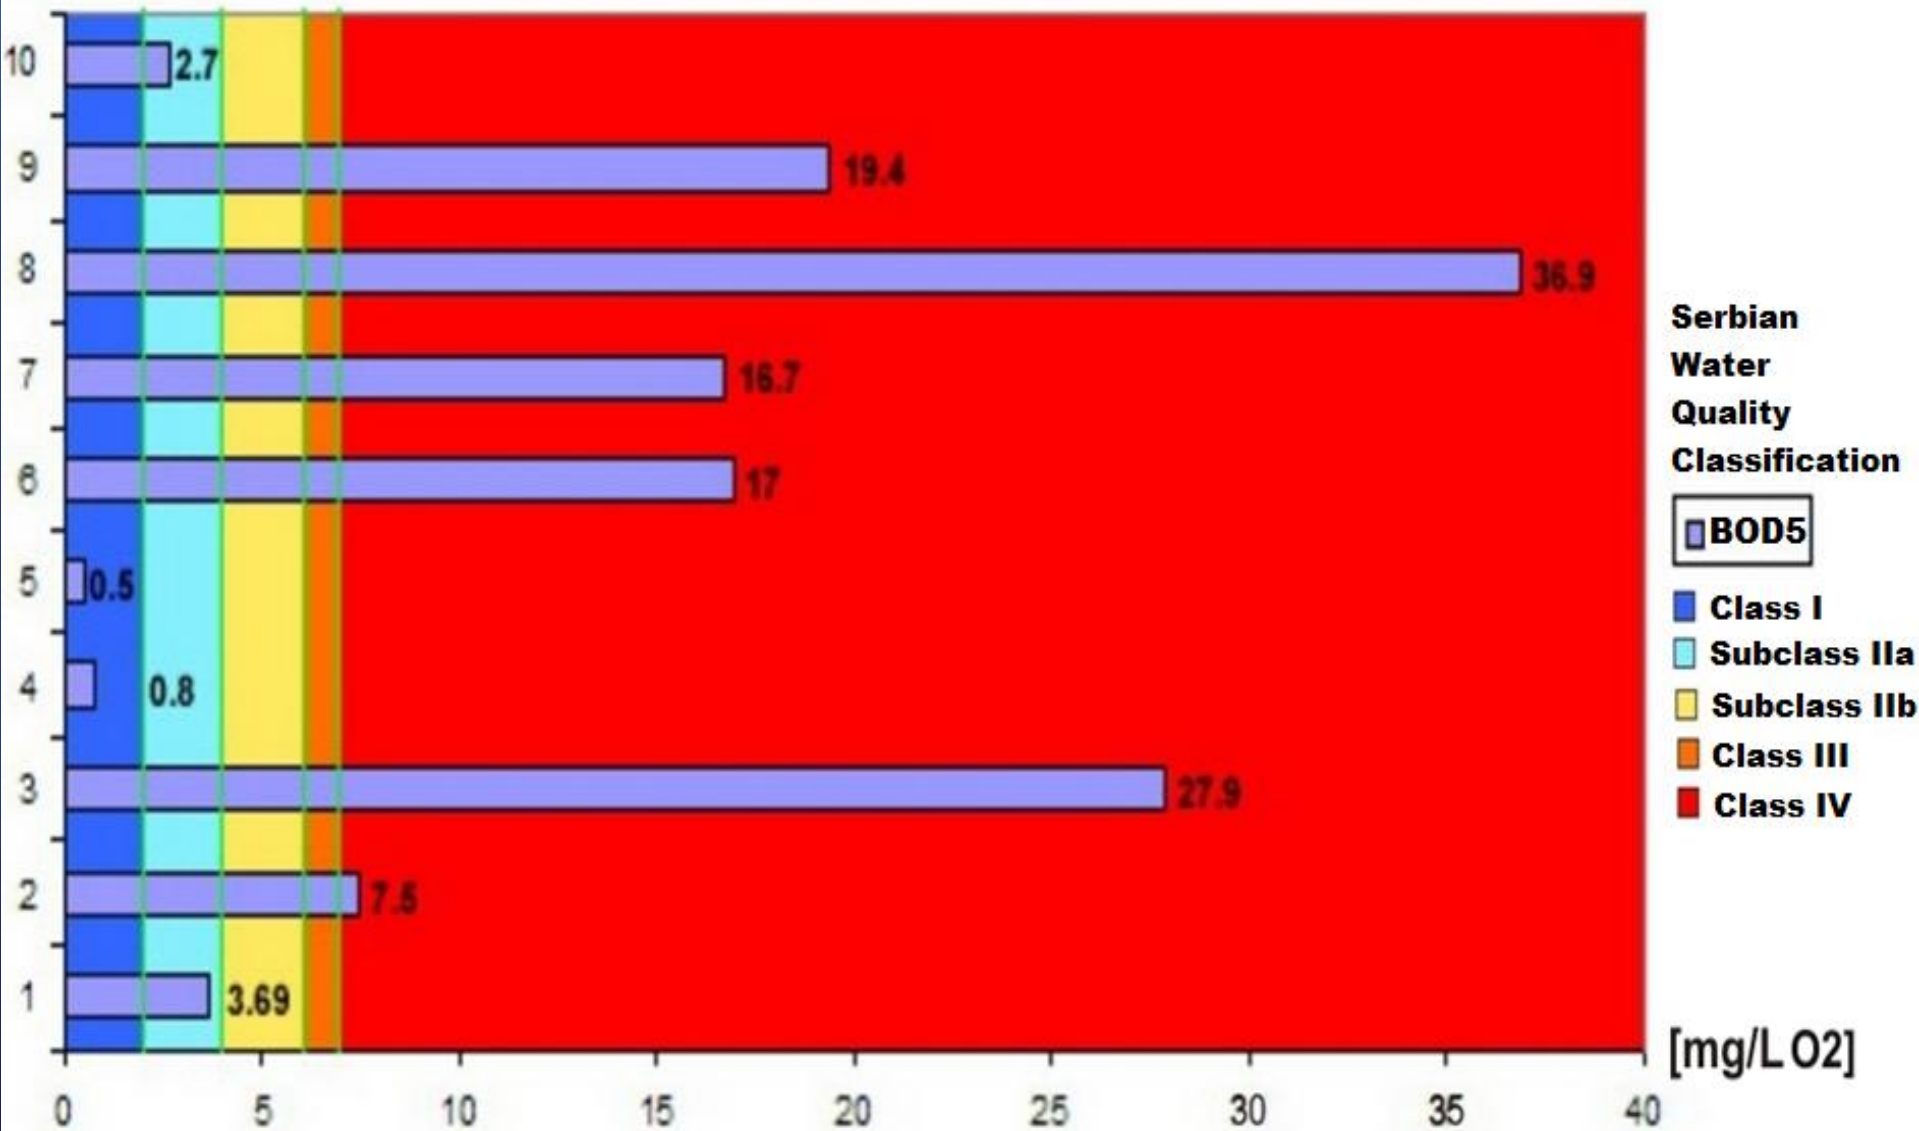
BOD5

- Waste waters and limited water that flows in the GBC network cause sedimentation of suspended matters, heavy metals, biodegradable organic matters, mineral oils and fecal microorganisms in extremely high concentrations.
- Water Quality: profiles 3, 8 and 9 are extremely polluted as shown by microbiological, physical-chemical and chemical parameters that are equal to sewerage water values (Figure 2).
- Examples on slides 17-20

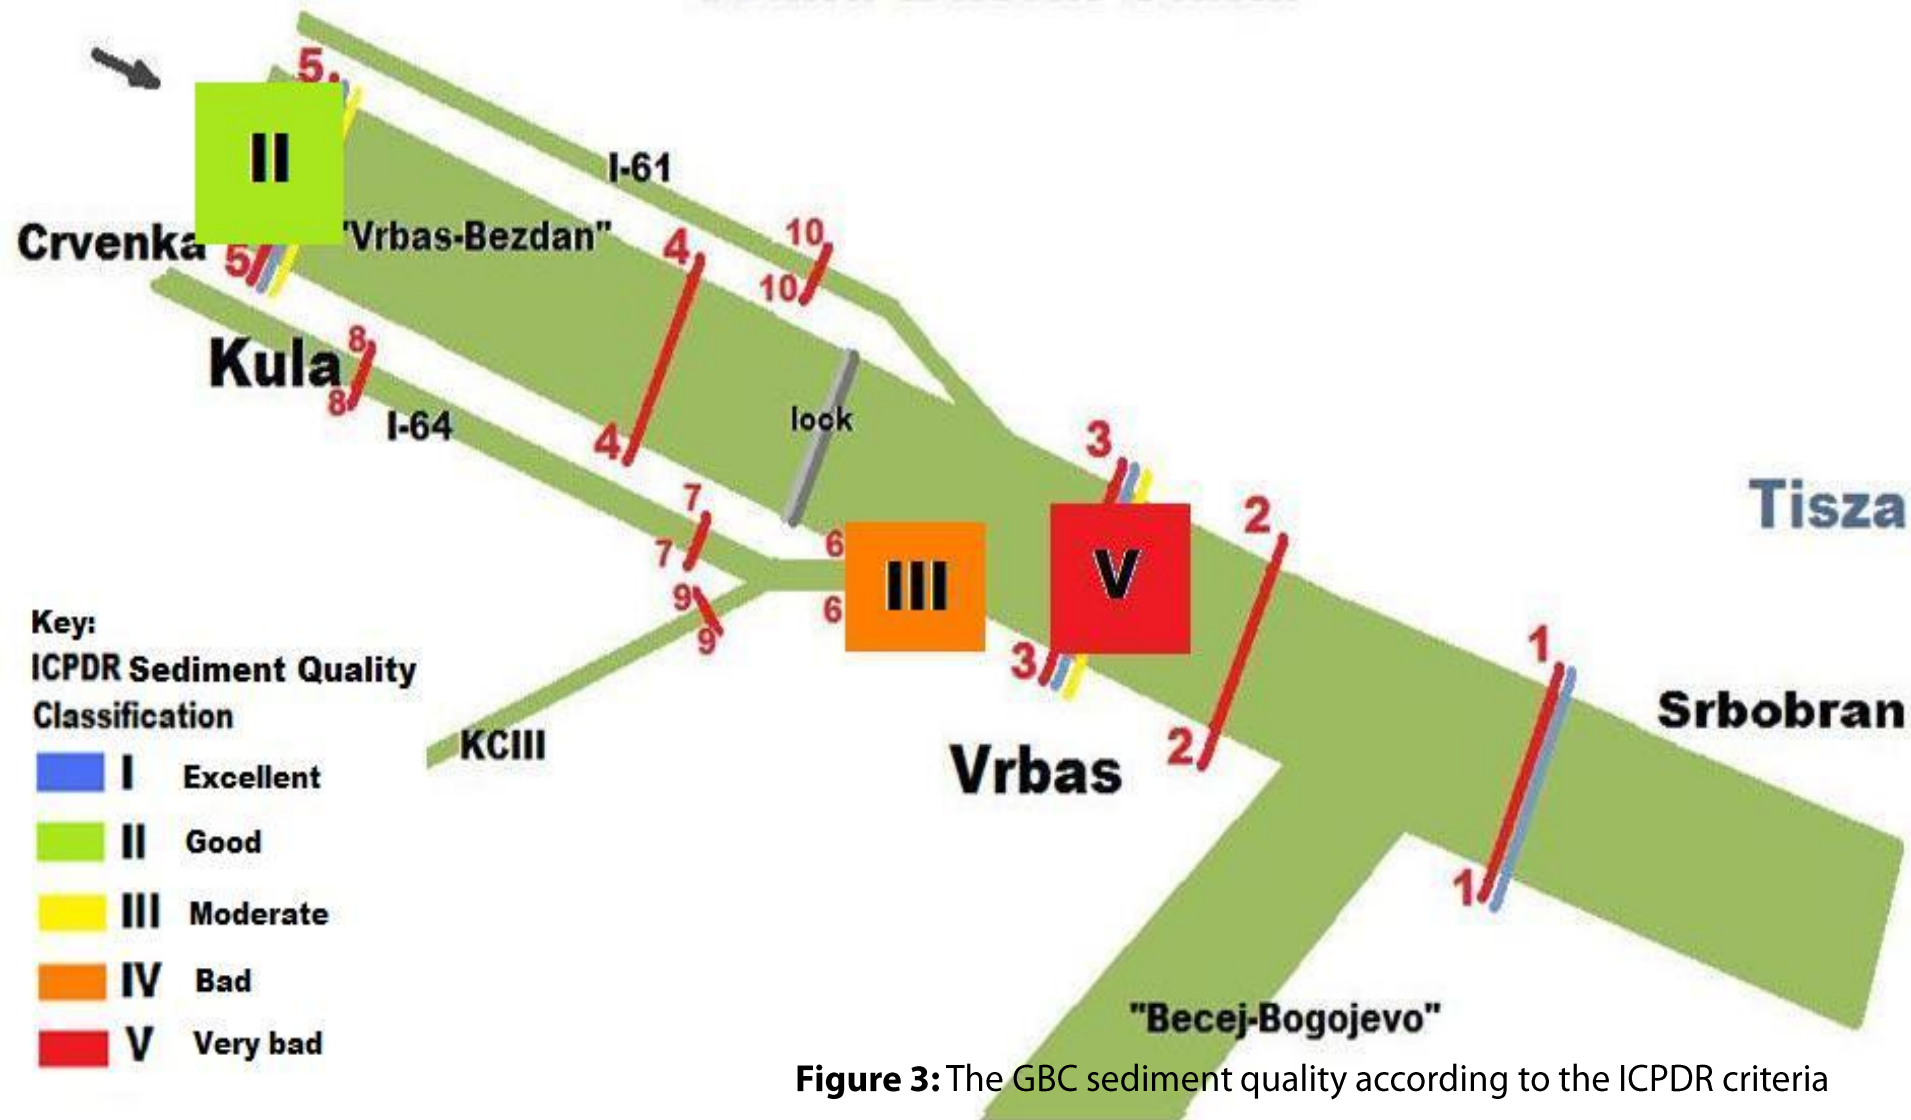
Figure 3: The GBC sediment quality according to the ICPDR criteria

- Assessed at profiles 3, 5 and 6, as shown in Figure 3.
- Profile 3 is the most polluted, with pollution mainly represented by a composite of soil and organic matter with a high heavy metals content (especially Zn, Cu and Cr in deeper layers of sediment), mineral oils and nutrients. Anaerobic conditions for decomposition of organic matters cause high content of sulphides.
