# Strengthening Capacities in Kosovo to Address Environmental Hot Spots

*Artana/Novo Brdo Mine  
Stan Tërg/Stari Trg Mine*

## Environmental Monitoring and Field Surveillance

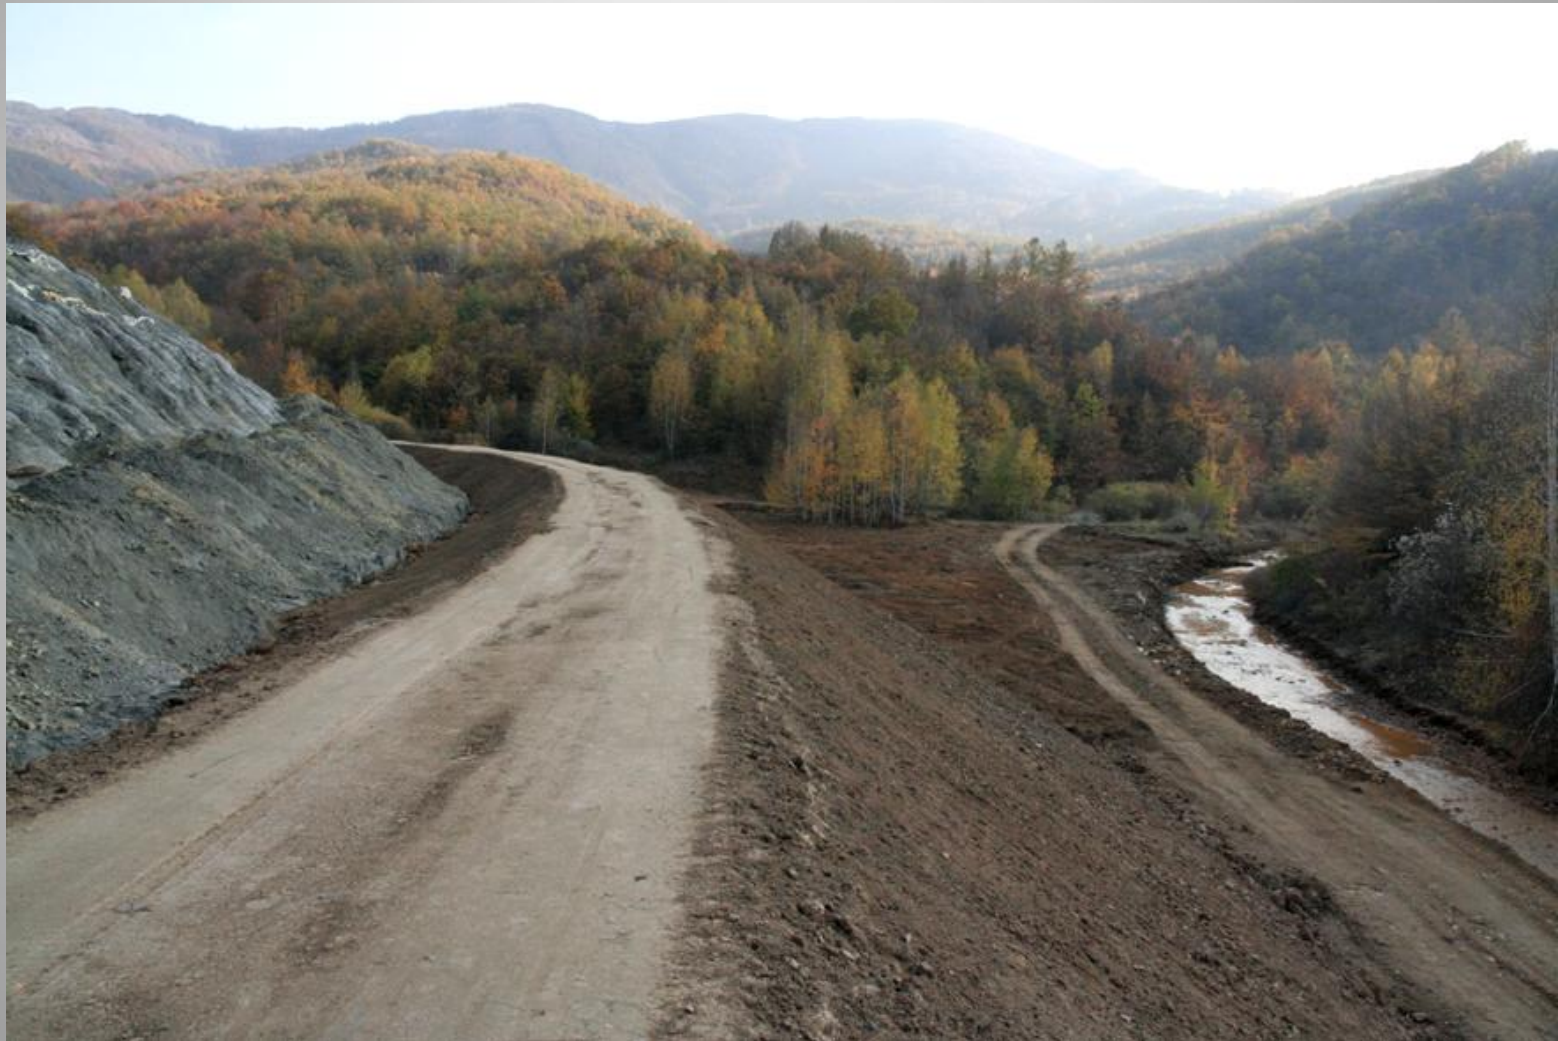
# Artana/Novo Brdo Mine - Tailings No2

- At both dump locations, the material has slumped into the stream bed, and added considerably to the pollution of the river. Pb, Zn, Cd
- The mine discharge is strongly acidic and contains a significant metal load
- Elementary School is located nearby (100m) Tailings T1 and mine
- Next settlements\houses are located 200m to 400m close to Tailings T2
- Downstream the mine, the water is not usable for drinking or irrigation (at least for 11 Km)
- ***Action undertaken by UNDP: River bad protection at Tailings T2***

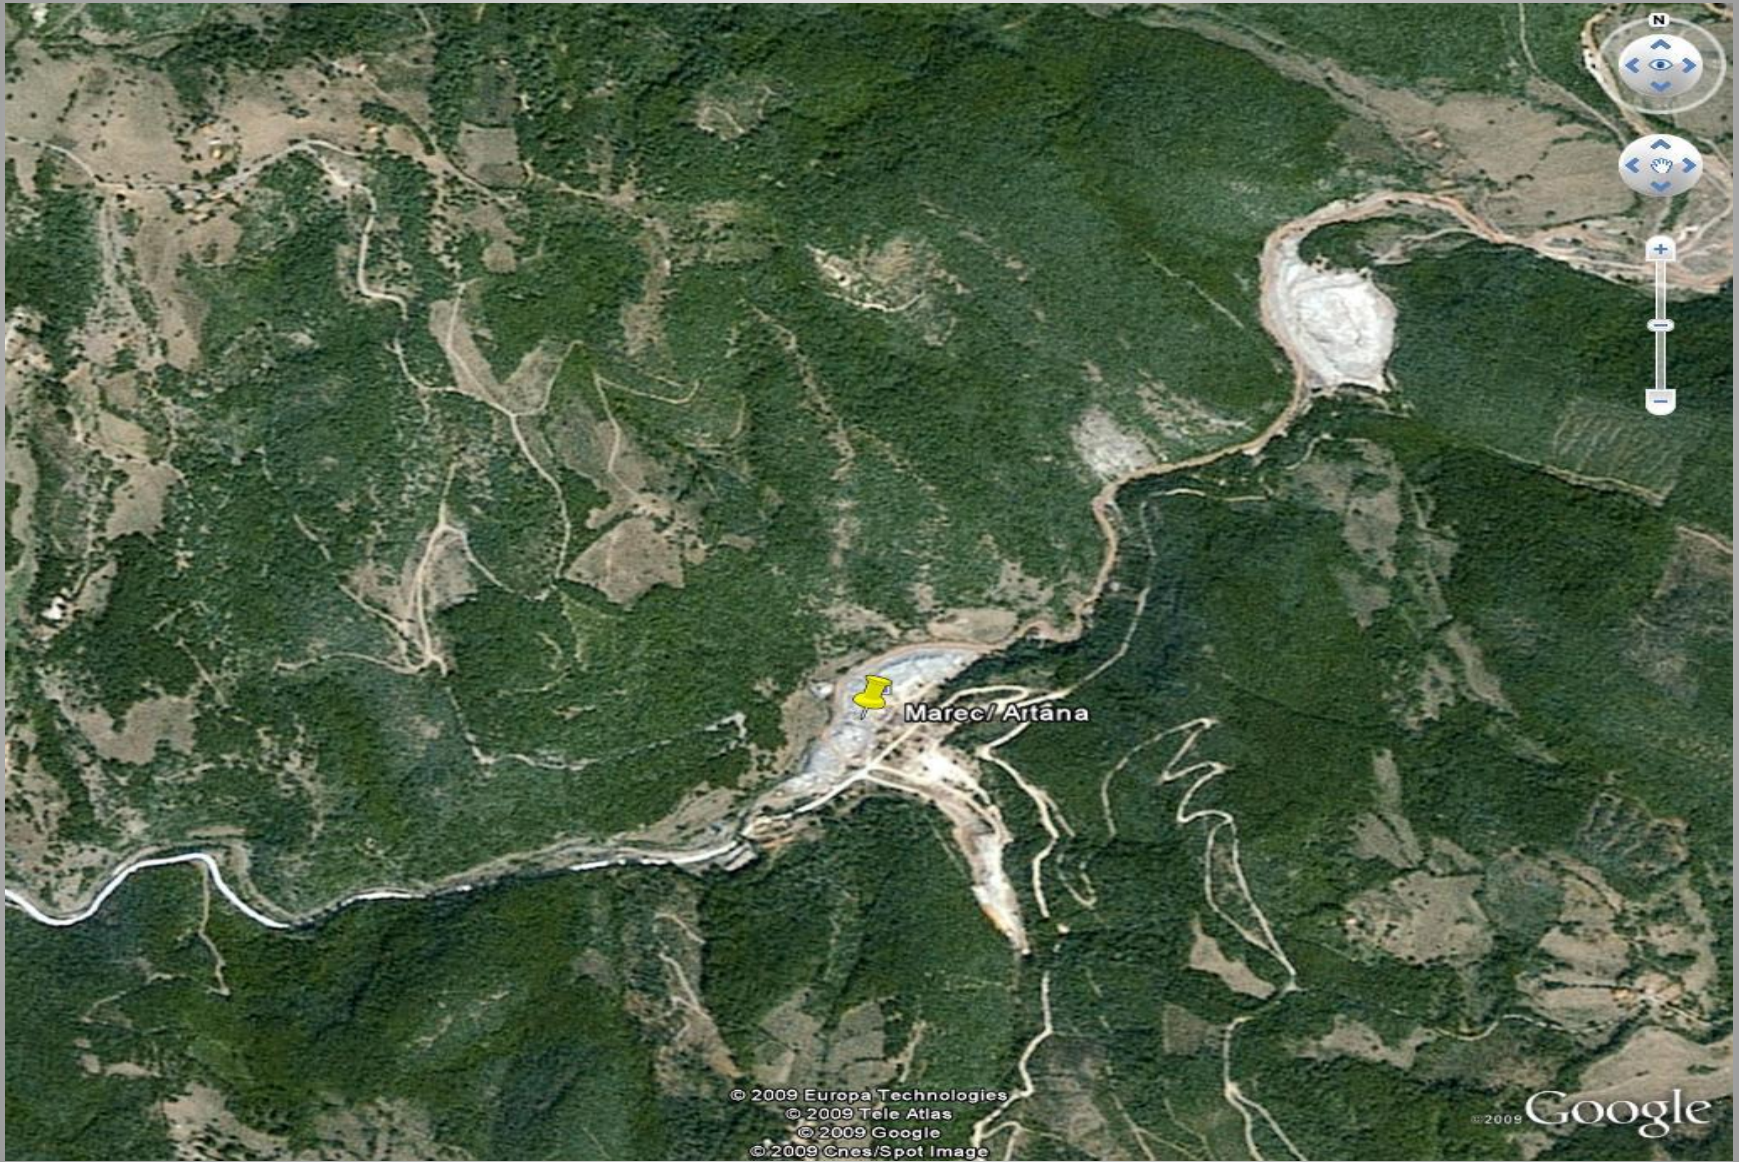
# Tailings 1 and Tailings T2, Artana/Nbrdo Mine

- pH 2 to 3
- metal load: Pb (0.8 mg/L), Zn (20 mg/L), Cd (0.24 mg/L)
- volume: about 250 m<sup>3</sup>/h

- Water samples from tailings No1: pH values of 2.5, and contained 0,035mg/l As, 0.58 mg/l Pb and 75mg/l Zn.

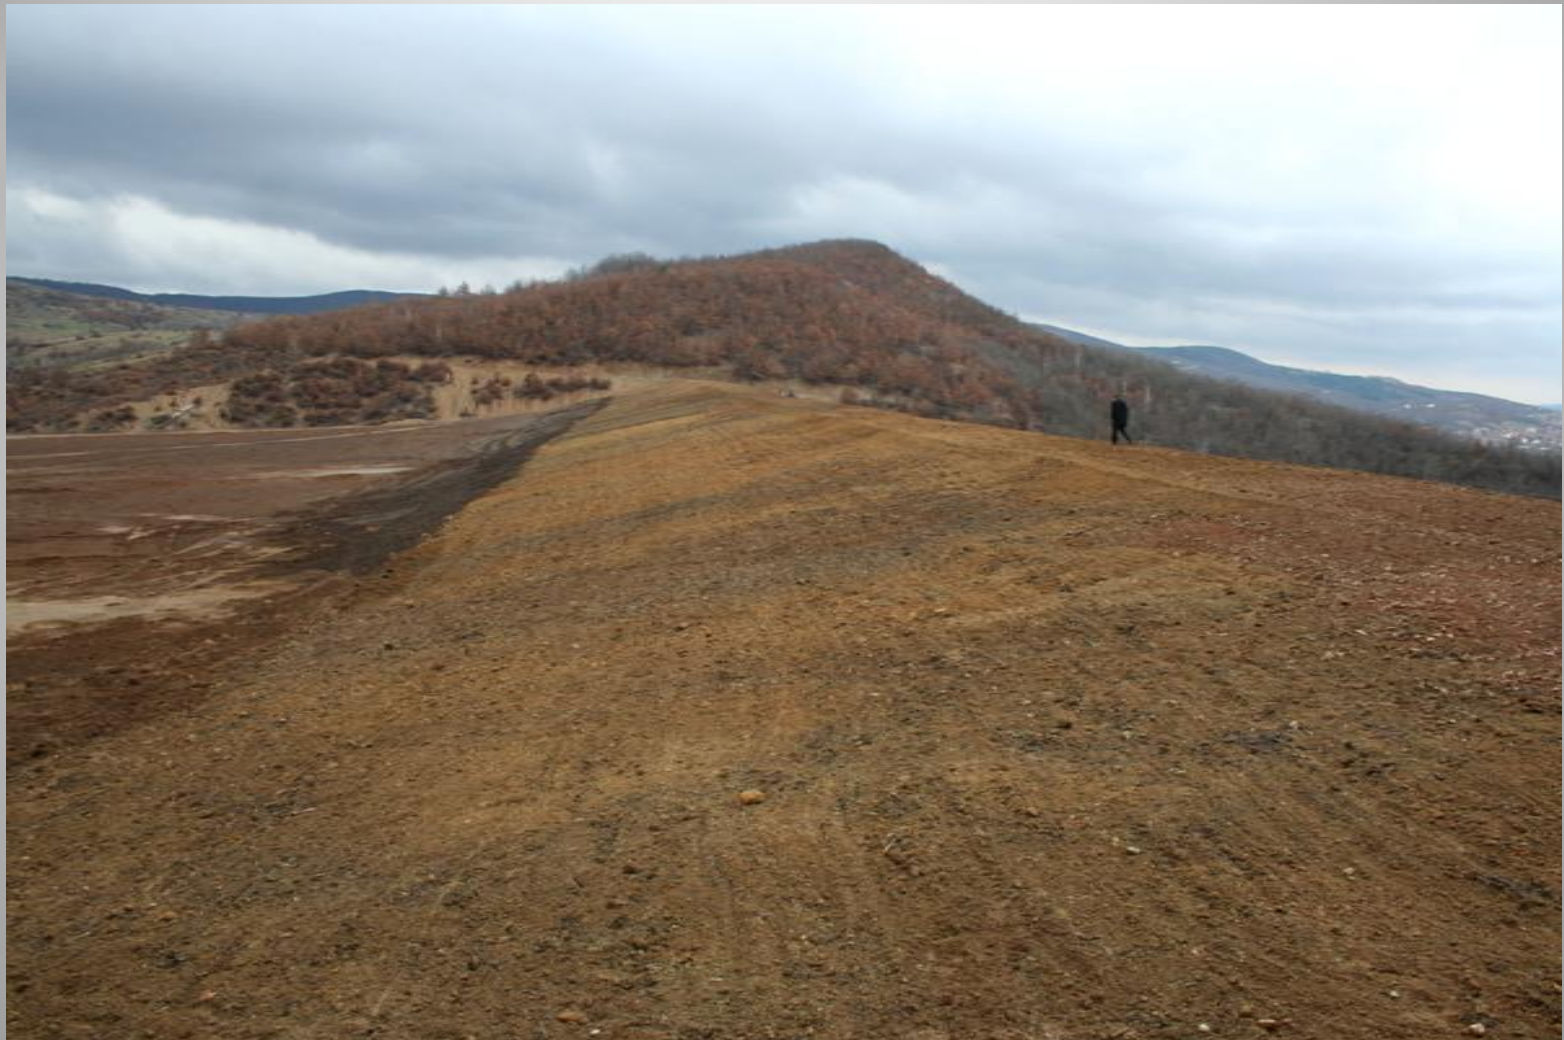
# Stari Terg/Zharkov potok Tailings

- Source of environmental problems is metal loading (Pb, Zn, Cd, As)
- Air-Dust remains one of the biggest environmental problem:
  - contamination of air by dust blown from the tailings during high wind events in dry weather periods
  - contamination of agricultural soil by deposition of suspended dust from tailings impoundments
  - contamination of residential soil by deposition of suspended dust form tailings
- ❑Tailings are reported to contain up to 1% Pb and 0.5% Zn, contamination of agricultural soil nearest the tailings impoundment via airborne dust could be significant.
- *Action undertaken by UNDP: Dam Crest Rehabilitation*

Monitoring measures proposed with respect to the air quality around the Zharkov Potok tailings:

- meteorological data

- concentration of airborne particulates:

installation of a low-volume sampler with combined inlets for the continuous determination of total suspended particulates.

- dust deposition rates:

installation of dust deposition gauges (e.g. ISO gauges, Frisbee Dust Deposition (FDD) gauges, or Bergerhoff gauges) in the surroundings of the tailings.
