Strengthening Capacities in the Western Balkans Countries to Address Environmental Problems through Remediation of High Priority Hot Spots

Environmental Hot Spot Serbia Remediation of the Grand Backa Canal

Monitoring of surface water and sediments quality in the Grand Backa Canal

MNE, 6-7/5/09

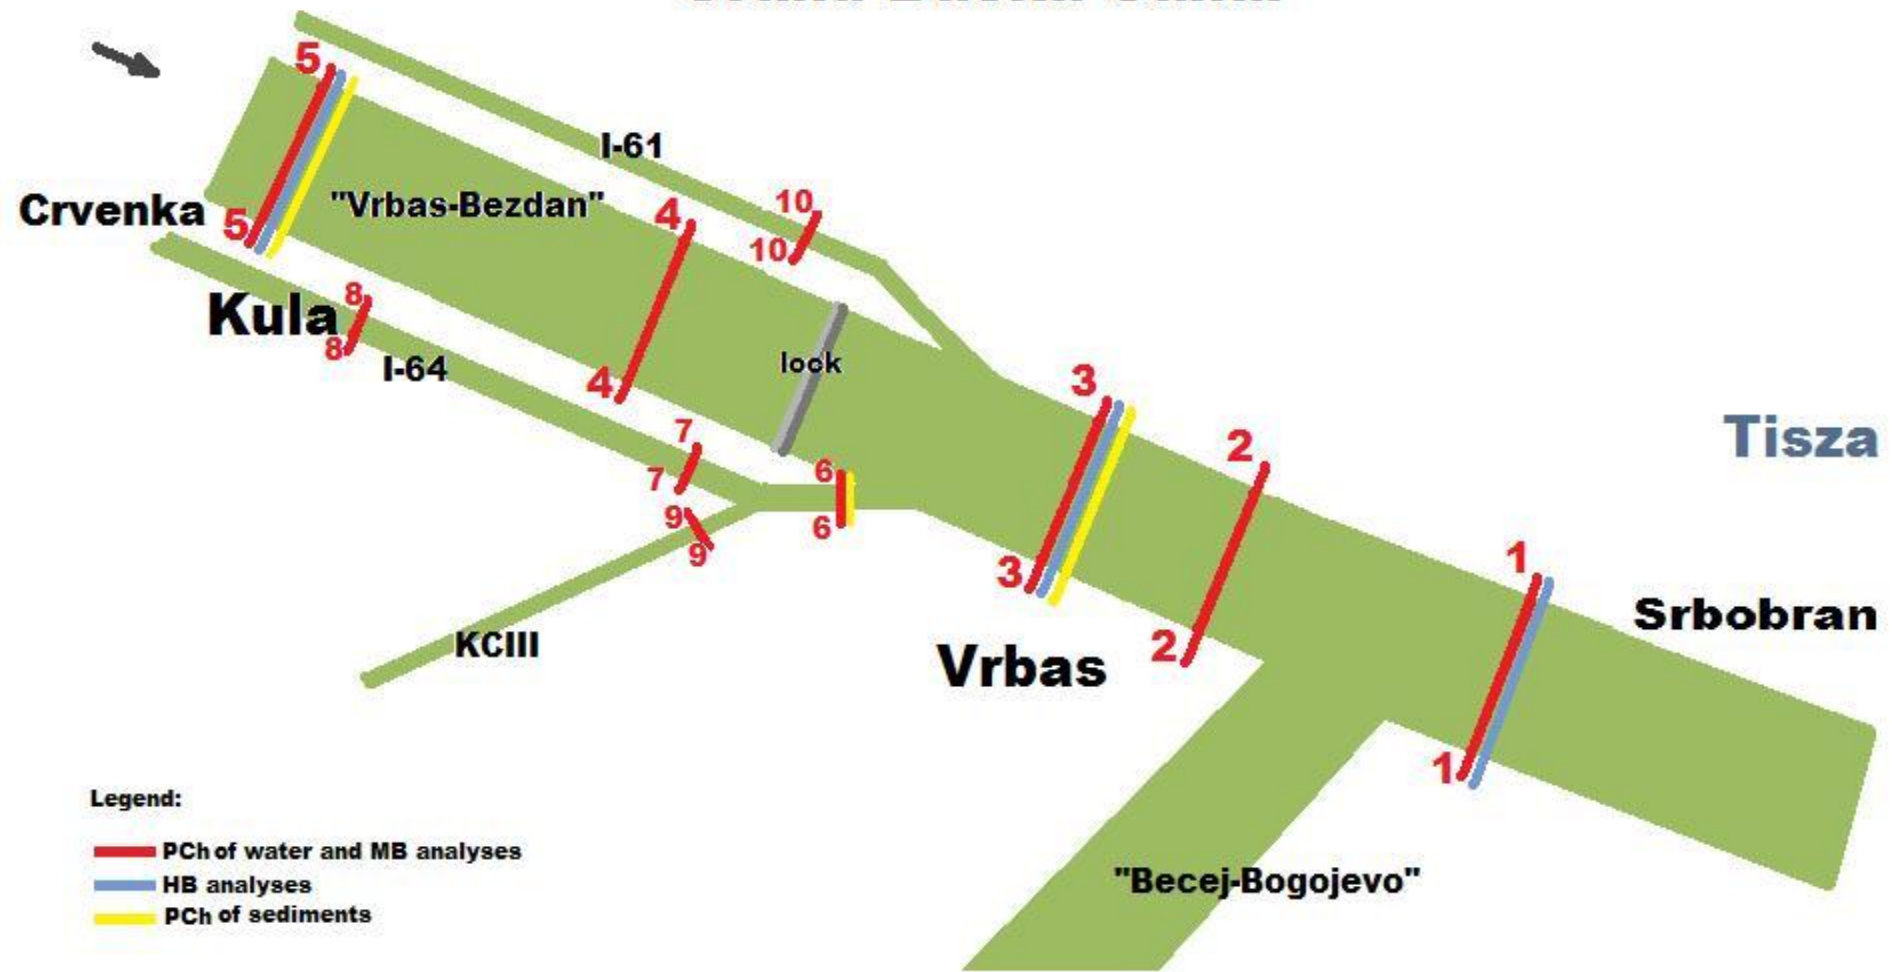
Figure 1: Monitoring profiles

Ten macrolocations (Fig. 1) were selected.

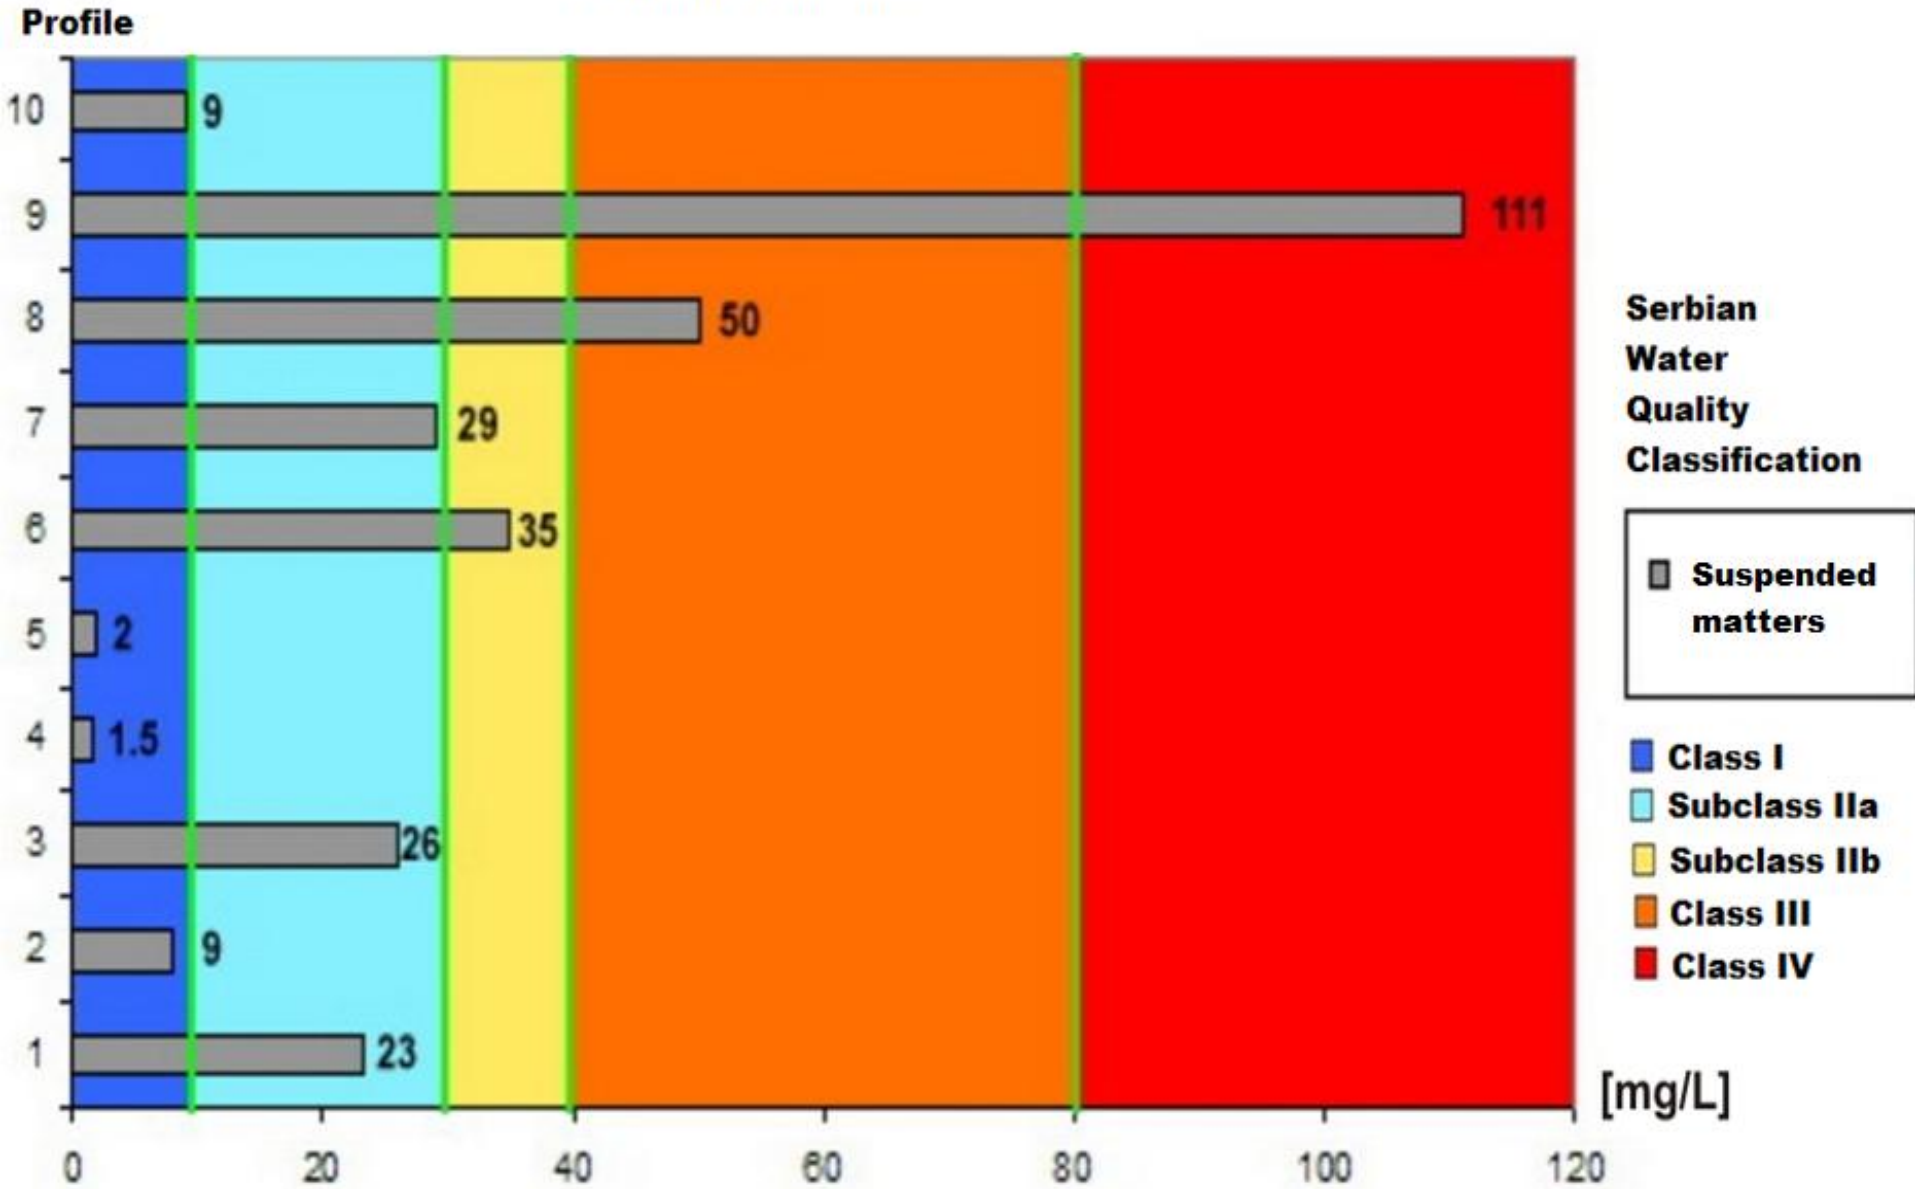
Suspended matters

- Waste waters and limited water that flows in the GBC network cause sedimentation of suspended matters, heavy metals, biodegradable organic matters, mineral oils and fecal microorganisms in extremely high concentrations.
- Water Quality: profiles 3, 8 and 9 are extremely polluted as shown by microbiological, physical-chemical and chemical parameters that are equal to sewerage water values (Figure 2).
- Examples on slides 17-20
