# WESTERN BALKANS ENVIRONMENTAL HOT SPOTS PROGRAMME

UNDP Albania Hotspot Programme

11 June 2010

# Clean up component

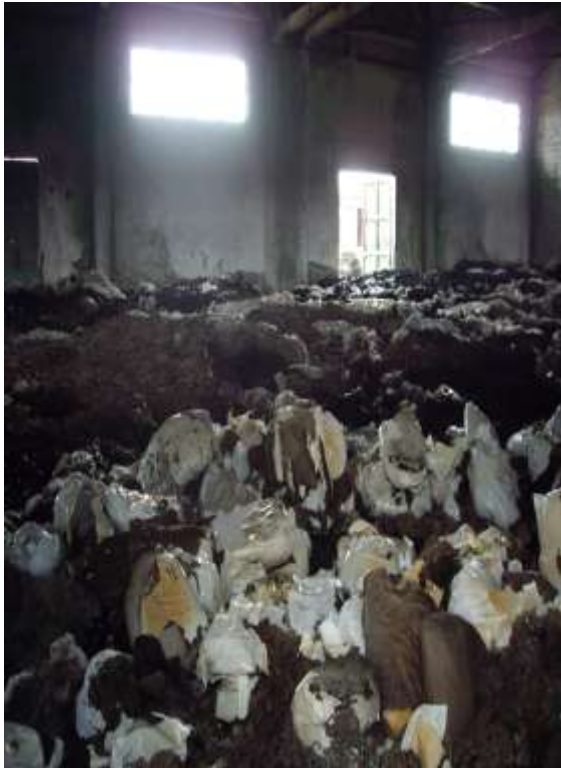
Before....

- Initially believed to be heavily polluted with pesticides;
- Actually resulted with chemicals ( $\text{Na}_2\text{SiF}_6$ ) and infected leather bits;
- Storehouse cleaned-up: not hazardous waste disposed to a landfill in Albania.

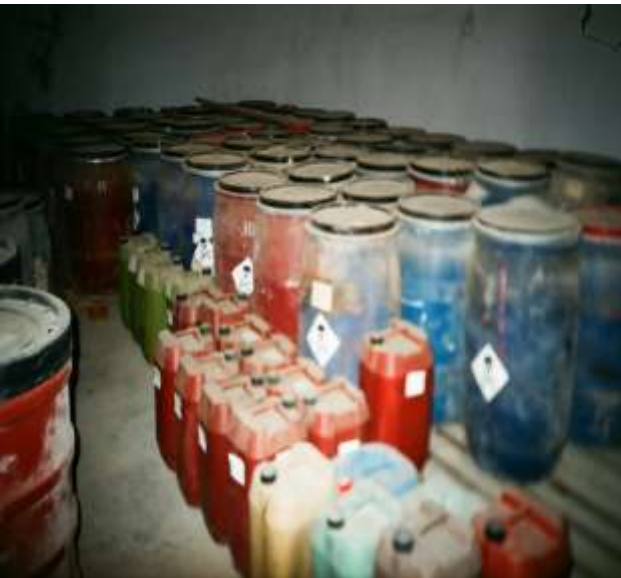
Before...

- **Balez chemical deposit and “satellite” sites** – 210 tons separated, analysed and repacked as per Basel Convention procedures;
- Repts and Rreshen mine tailing facilities:
